Natural aging mechanism of buried polyethylene pipelines during long-term service

Ying-Chun Chen ^a, Yan-Feng Li ^a, Yan Xi ^{a,*}, Qiang Li ^b, Qi Lu ^a, Jie Yang ^a^a Beijing University of Technology, Beijing, 100124, China^b Xinjiang Inspection Institute of Special Equipment, Urumqi, 830011, Xinjiang, China

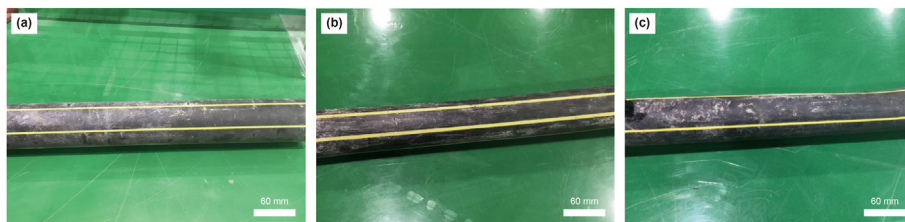
Fig. 1. Photos of buried pipelines in service; (a) 9 years in service, (b) 13 years in service, and (c) 18 years in service.

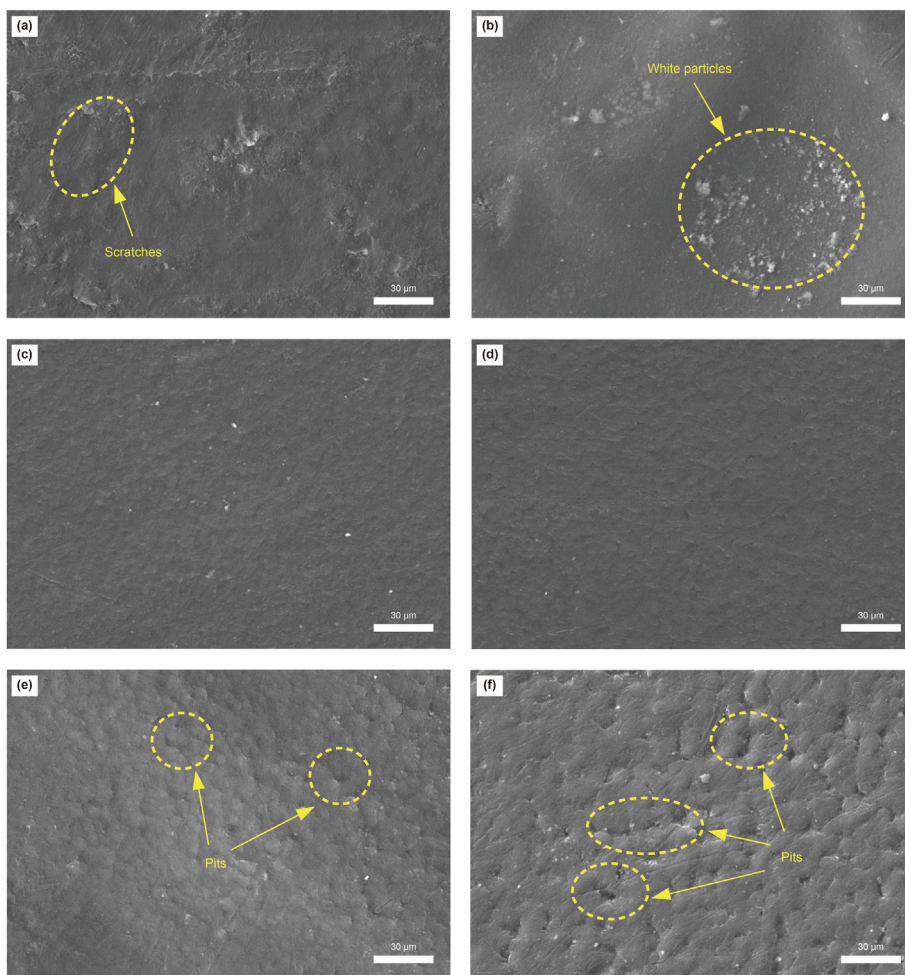
Fig. 13 shows the inner surface microstructure of polyethylene pipelines with different service times. After 9 years in service (Fig. 13(b)), white particles appeared on the inner surface. After 11

and 13 years in service (Fig. 13(c) and (d)), there were many small pits and lines on the surface. However, compared with the new pipeline (Fig. 13(a)), their inner surfaces are smoother without obvious scratches. When the service time reached 13 and 16 years (Fig. 13(e) and (f)), the depth of the pits on the inner surface deepened, and the range enlarged. The overall roughness of the inner surfaces increased, especially the pipeline in service for 16 years, whose pits connected and formed fine cracks.

Comparing Figs. 12 and 13, there is no obvious difference between the microstructure of the outer and inner surfaces of the new pipeline. However, the microstructure gradually varies with the service time when the pipeline is in service. Many irregular defects appear on the outer surface, and the aging degree is severe. In contrast, the inner surface is slightly aged, and only shallow pits are produced. It shows that the aging rate greatly relates to the exposed environment. The outer surface of the pipe is in direct contact with the soil. A large amount of H_2O and O_2 in the soil environment

Fig. 13. The inner surface microstructure of polyethylene pipelines with different service times: (a) New pipeline, (b) 9 years, (c) 11 years, (d) 13 years, (e) 16 years, and (f) 18 years.

As shown in Fig. 13(a), scratches formed on the inner surface due to processing factors. The rough particles of the matrix increased the drag force on the inner surface during natural gas flows. Under the long-term circulation of natural gas inside the pipeline, the fluid polished the inner surface of the pipeline. Therefore, in Fig. 13(b–d), the inner surface was gradually flattened. After 16 and 18 years in service, antioxidant consumption and internal surface aging products increased gradually. Under the long-term flow of gas pipeline transportation, loose aging products are removed. When the air flows through the holes on the inner surface, the increased shear forces produce high-energy and small-scale turbulence that further expands the holes.

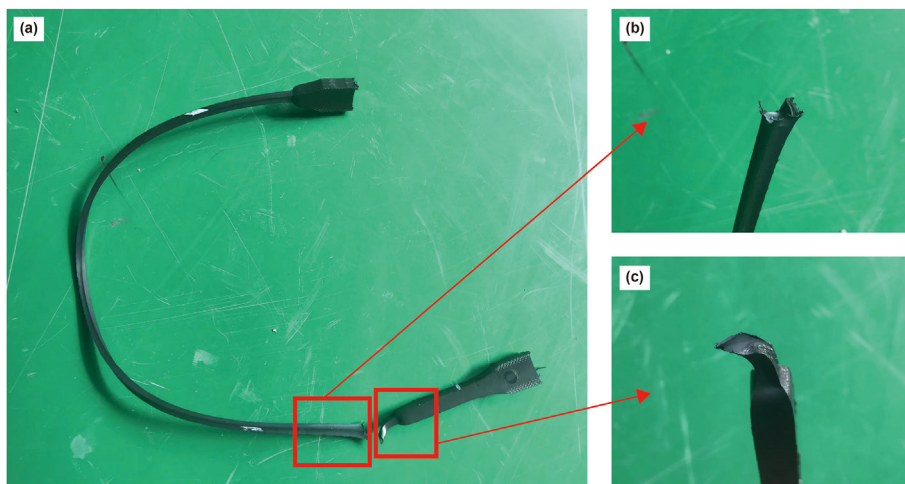
According to the tensile test results in Section 3.1, the mechanical properties decrease significantly with the increase in service time. Both the tensile strength and elongation at the break of the tensile sample decreased. To explore the mechanism of pipeline aging on its mechanical properties, the microstructure of the fracture surface was observed by SEM. Fig. 14 shows the sample photos after the tensile test. It is seen in Fig. 14(b) and (c) that the fracture surface of the extended sample part is concave, and the fracture surface of the short sample part is a protruding surface.

Fig. 14. Tensile fracture surfaces of polyethylene pipeline sample; (a) Fractured sample profile, (b) fracture surface of the extended sample part, and (c) fracture surface of the short sample part.

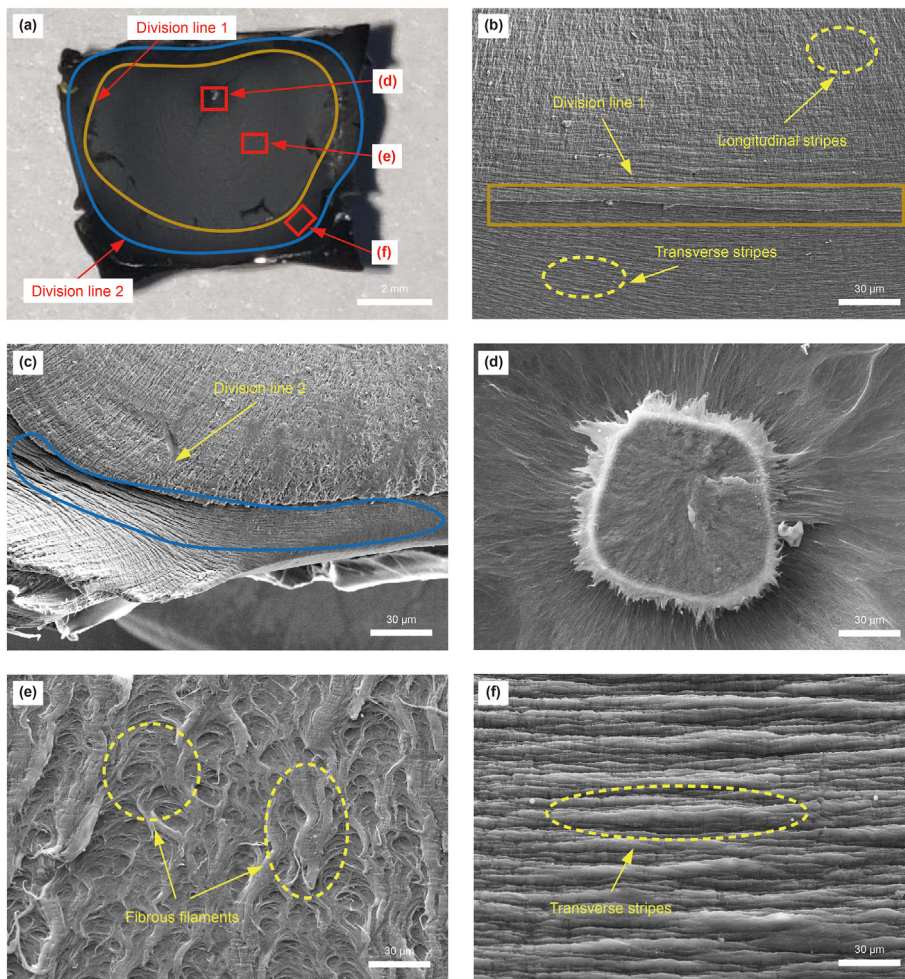
Fig. 15 shows the microstructure of the tensile fracture surface that was in service for 9 years. As shown in Fig. 15(a), the yellow and blue lines represent division lines 1 and 2, respectively. The surface morphology of the fracture can be divided into three areas according to the division line: The main collapse area is inside division line 1. The buffer area is between division lines 1 and 2. The first fracture area is outside division line 2.

Fig. 15(b) and (c) show the microstructure near division lines 1 and 2, respectively. According to Fig. 15(b), the texture of the main collapse area (inside division line 1) is longitudinal stripes. The texture of the buffer area is a transverse stripe. Close to division line 1, the texture of the main collapse area gradually becomes a transverse stripe. Compared with it, the cracks near division line 2 and the first fracture area are deeper in Fig. 15(c).

Fig. 15(a) are identified as follows: the central hole of the fracture surface is shown in Fig. 15(d), and the side wall of the main collapse area is shown in Fig. 15(e), and the buffer area is shown in Fig. 15(f). It is seen in Fig. 15(e) and (f) that the fiber texture of the side wall of the main collapse area and the buffer area are significantly different. The section of the main collapse area shows fiber pullout, and the adhesion between the fiber and the surface matrix is less. Since the medium-density polyethylene is mainly in C=C configuration and has good ductility, it produces obvious filaments during elongation. The buffer area belongs to the outer layer of the elongation sample. In the elongation process, the sudden stress change in a short time is significant. Therefore, it breaks first, and the section does not produce obvious filaments.

Fig. 15. Fracture surface of the tensile sample with 9 years' service; (a) Fracture surface image, (b) microstructure near division line 1, (c) microstructure near division line 2, (d) central hole, (e) main collapse area, and (f) buffer area.

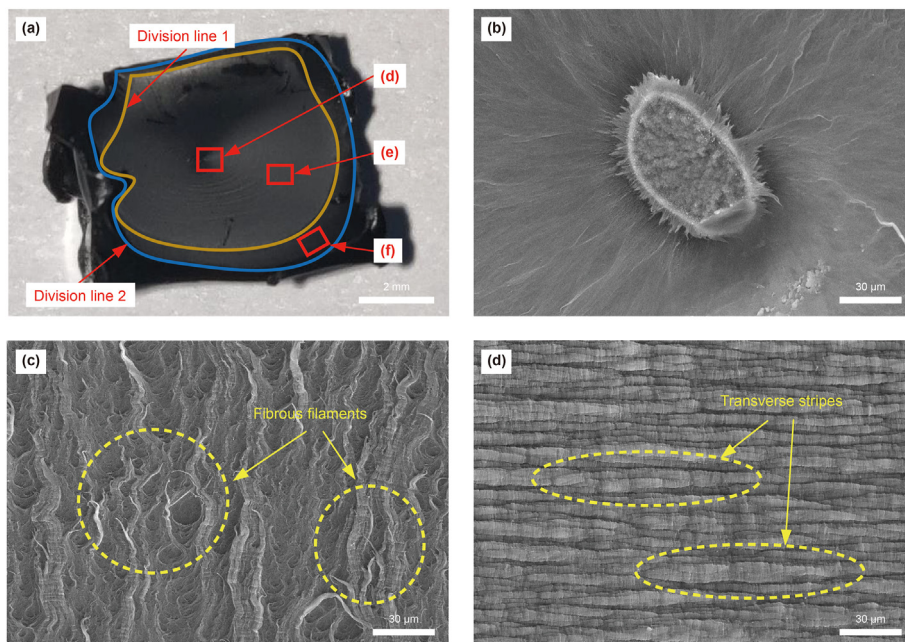
Figs. 16 and 17 show the microstructure of the tensile fracture surfaces with 13 and 18 years in service, respectively. Comparing Figs. 15–17, it can be seen that there is no significant difference in the surface morphology of the central holes (Figs. 15(d), Fig. 16(b), Fig. 17(b)) and the first fracture area (Figs. 15(f), Fig. 16(d), Fig. 17(d)). However, through the surface morphology of the buffer area (Figs. 15(e) and Fig. 16(c), Fig. 17(c)), it is seen that with the increase in service time, the pullout of the fiber from the matrix gradually weakens, and the fiber filament is shorter. It indicates that with the increase in service time, the aging of the pipeline becomes severe, the C=C bond breaks, and the material ductility is weakened.

Fig. 16. Fracture surface of the tensile sample with 13 years' service; (a) Fracture surface image, (b) central hole, (c) main collapse area, and (d) buffer area.

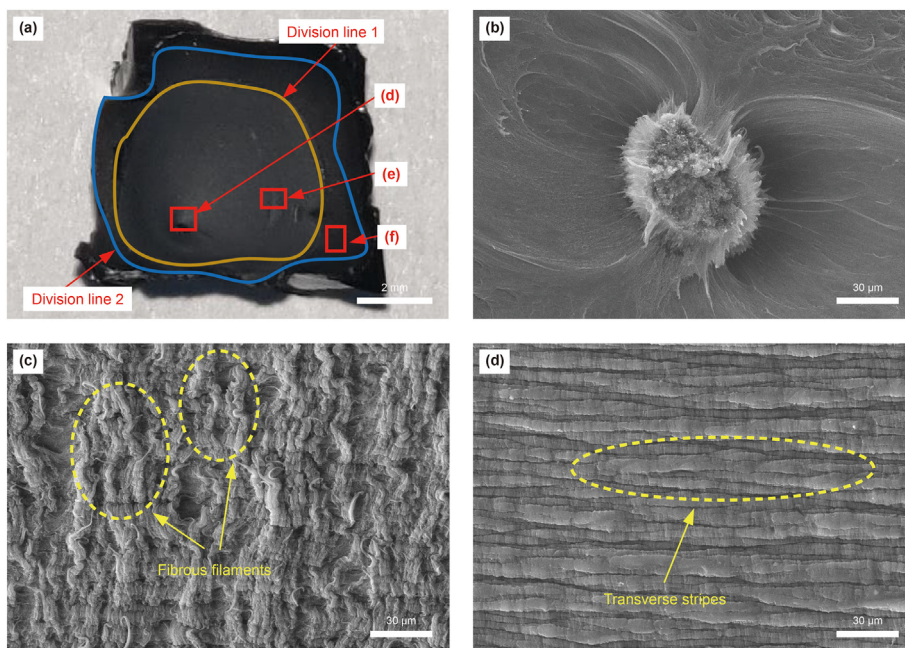
Fig. 17. Fracture surface of the tensile sample with 18 years' service; (a) Fracture surface image, (b) central hole, (c) main collapse area, and (d) buffer area.
