# Effects of direct stray current on the performance of cathodic disbonding epoxy powder coatings

## Abstract

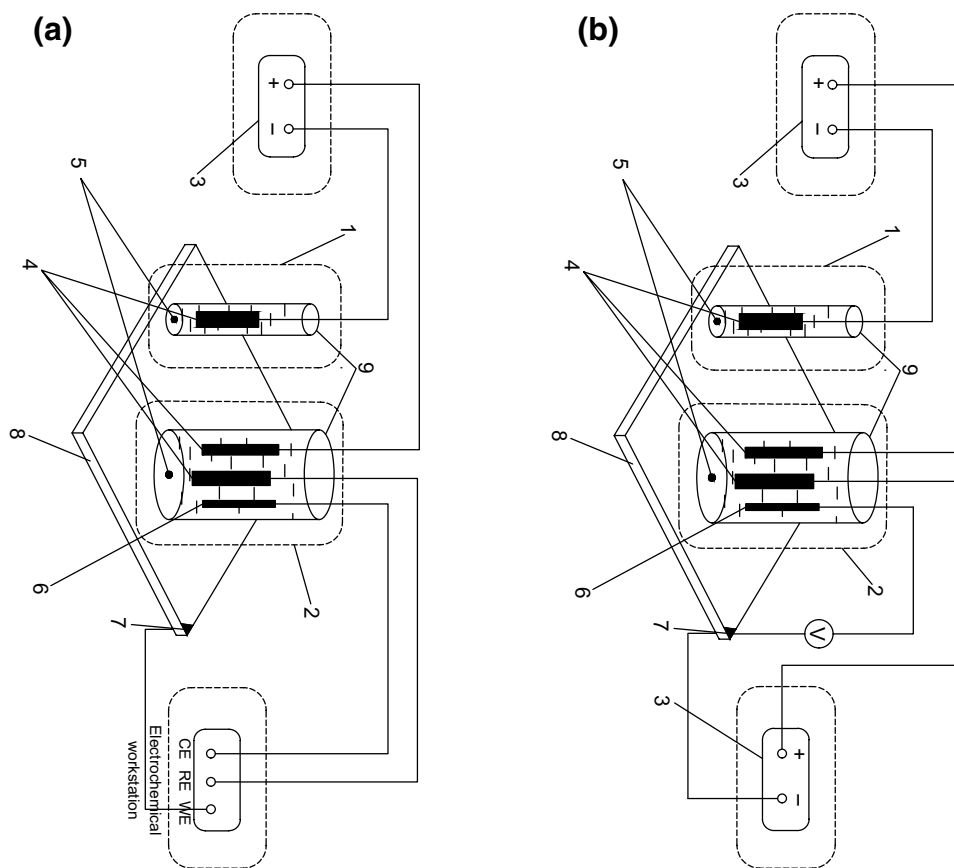
Fig. 1 Experimental device diagram

As shown in Fig. 1, a blind hole with a diameter of 3.2 mm was drilled at the center of the test sample to expose the metal substrate as the working electrode for electrochemical tests. A PVC pipe with a diameter of 75 mm and a length of 12 cm was used to hold an electrolyte solution in the electrochemical test experiment system and the cathodic protection system as shown in Fig. 1. The center of the PVC pipe was aligned with the center of the blind hole at the center of the sample. The bottom of the PVC pipe was bonded to the sample, and the simulated etching liquid was injected through the upper opening. One corner of the sample is polished to remove the anti-corrosion layer to connect the working electrode of the electrochemical workstation (CHI660D) from Beijing Huake Putian Technology Co., Ltd., or to connect the negative pole of the DC power supply (MCH-305DII) from Shandong Jingjiu Technology Co., Ltd. In the electrochemical test experiment as shown in Fig. 1a, three-electrode systems were adopted. The working electrode was a metal-coating system, a platinum electrode was used as the auxiliary electrode, and a saturated calomel electrode was used as the reference electrode. In the cathodic protection system

as shown in Fig. 1b, the cathodic protection potential was controlled at  $-3.5$  V. As shown in Fig. 1b, the negative pole of the DC power supply was connected to the corner of the test sample and the positive pole was connected to the platinum electrode. A  $10\text{ mm} \times 10\text{ mm}$  area was selected in another corner corresponding to the corner removed the coating of the test sample, and a blind hole with a diameter of  $3.2\text{ mm}$  was drilled at the center of the region, exposing the metal substrate as a current path for applying DC stray current in the auxiliary system as shown in Fig. 1. A PVC pipe with a diameter of  $25\text{ mm}$  and a length of  $12\text{ cm}$  was used to hold the electrolyte solution in the auxiliary system. The center of the PVC pipe was aligned with the center of the blind hole at the edge of the sample. A DC stabilized power supply was used to provide stray current. The positive stray current flowed from the auxiliary system to the electrochemical test experiment system, but the negative stray current flowed inversely from the electrochemical test experiment system to the auxiliary system.

*Group A* As shown in Fig. 1a, the wires 1 and 2 were, respectively, connected to the negative and positive terminals in the auxiliary system. The current flowed from the auxiliary system to the experimental system, which was called current positive inflow. The DC stray current interference voltage was applied with  $2\text{ V}$ ,  $4\text{ V}$ ,  $8\text{ V}$  or  $16\text{ V}$ , respectively.

*Group B* As shown in Fig. 1, the wires 1 and 2 were, respectively, connected to the positive and negative terminals in the auxiliary system. The current flowed from the experimental system to the auxiliary system, which was called current negative inflow. The DC stray current interference voltage was applied with  $2\text{ V}$ ,  $4\text{ V}$ ,  $8\text{ V}$  or  $16\text{ V}$ , respectively.

As shown in Fig. 1a, electrochemical tests were completed with the electrochemical workstation. The test frequency of the electrochemical impedance spectroscopy (EIS) was from 0.1 Hz to 100 kHz, and the amplitude was 10 mV. DC interference was interrupted during electrochemical measurement. Electrochemical test results were fitted with ZsimpWin software. After the experiment, the cathode disbonding distance was calculated to 0.1 mm accurately in accordance with the requirement in SY/T 0315-2013.

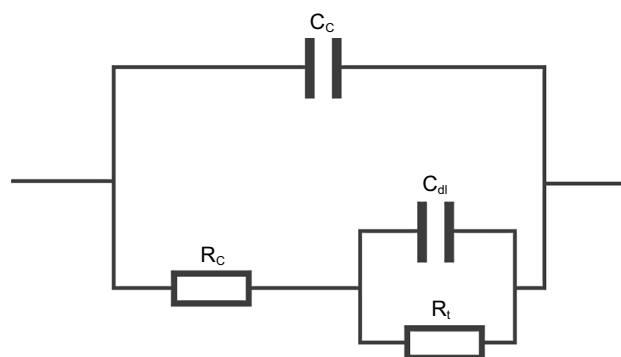
**Fig. 3** Equivalent circuit model (C(R(RC)))

Under the DC interference voltage of 2 V, the circuit (C(R(RC))) is used as fitting model at 7 h as shown in Fig. 3, and the circuit (C(R(RW))) is used as fitting model within 20–48 h as shown in Fig. 4. The fitting results are given in Table 1. At the beginning of the test, the medium solution reaches the intersection of the coating and the metal interface. The  $C_{dl}$  represents electric double-layer capacitor, and  $R_t$  represents charge transfer resistor. The  $C_c$  represents coating capacitor and  $R_c$  represents coating resistance. The  $W$  represents diffusion impedance of Warburg. The  $C_{dl}$  and  $R_t$  mainly reflect the transformation of the charge between the metal and solution interface. At the same time, the medium solution is also infiltrated into the metal surface through the coating, and  $C_c$  and  $R_c$  mainly reflect the permeability of the corrosive medium and the degree of disbonding of the coating between metal substrate and coating in the process. As the solution of the medium continues to pass through the gap between the coating and metal substrate, the medium

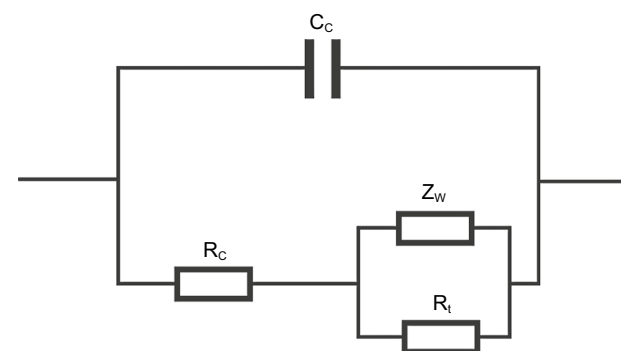
**Fig. 4** Equivalent circuit model (C(R(RW)))

solution passes through the gap between the particles. The characteristics of the Warburg impedance on the impedance spectrum exhibit due to the blocking of particles such as fillers in the coating. The W characterizes a situation in which mass transfer (dielectric solution diffusion) processes are hindered. Since the diffusion of the medium solution is formed between the coating and the metal substrate, it can be known that the coating has been peeled off at this time.

in Fig. 9. The other curves are fitted with the circuit diagram shown in Fig. 4. The fitting results are given in Table 4.

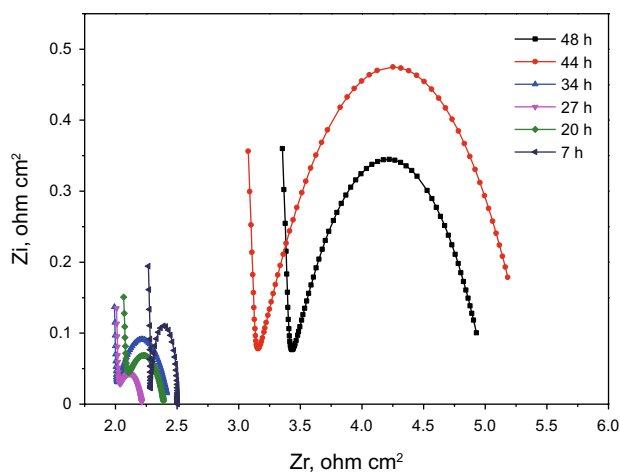
**Fig. 5** Nyquist diagrams of experimental system under DC interference voltage of 4 V

The evolution of impedance spectrum with time under DC interference voltage of 4 V is shown in Fig. 5. The variation of impedance spectrum at high frequencies with 4 V DC interference is similar to that with 2 V DC interference, and the fluctuation of its high-frequency arc is larger, which indicates that more severe metal corrosion occurred under 4 V DC interference. In the middle- and low-frequency region, the radius of the arc in Fig. 5 first decreased and then increased. When the immersion time reached 44 h or 48 h, a slight decrease occurred.

Under the condition of 4 V DC interference, the circuit (C(R(RC))) is fitted for Nyquist diagrams at 7 h, and the circuit (C(R(RW))) is fitted for Nyquist diagrams from 20 to 48 h. The fitting results are given in Table 2. According to the fitting results, the value of  $R_l$  is relatively small before 34 h and increases by about 50 times at 44 h. This indicates that the coating has been stripped to a certain extent at the initial stage, and the reaction charge has transferred between the coating and the metal substrate, but the resistance is relatively small. When the reaction proceeds for 44 h, the corrosion products are continuously deposited as the coating is further stripped. The charge

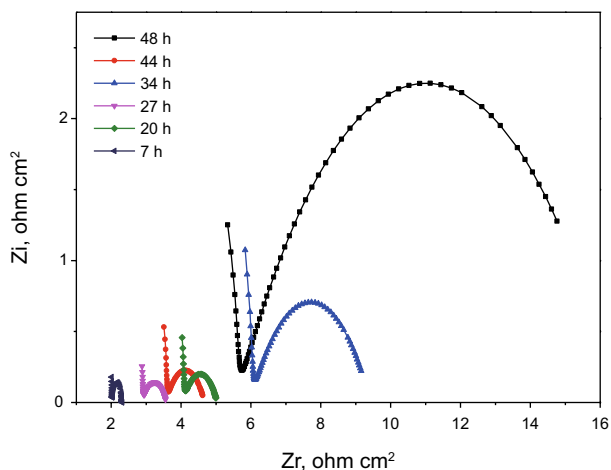
**Fig. 6** Nyquist diagrams of experimental system with DC interference voltage of 8 V

The evolution of EIS with time under DC interference voltage of 8 V is shown in Fig. 6. The fluctuation of the impedance value over time significantly increases compared with that under 2 V or 4 V DC interference. The radius of the low-frequency zone fluctuates with time, and the amplitude is also increasing. The curves are fitted with the circuit diagrams in Figs. 3 and 4, and the results are given in Table 3. The value of  $R_c$  is determined by both the coating resistance and the deposited corrosion products. Under 8 V DC interference, the value of  $R_c$  is greater than that of 2 V or 4 V interference. In the process of reaction, the resistance of coating gradually decreases with the deterioration of the coating performance. The increase in the value of  $R_c$  indicates that the deposition phenomenon of the corrosion products is more pronounced, i.e., the dissolution reaction of the anode is more severe. In addition, the value of  $R_l$  increases rapidly in a short period of time, indicating that the disbonding speed of the coating increases and the degree of disbonding increases during the test time. The  $W$  value is an order of magnitude smaller than that of 2 V or 4 V interference, and under the 8 V DC interference, the degree of disbonding of the coating is increasing.

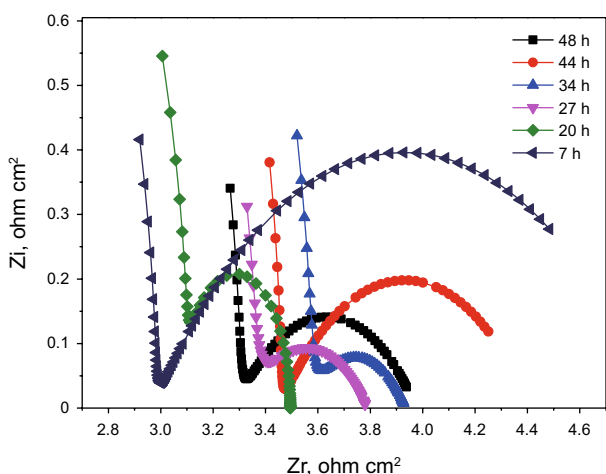
**Fig. 7** Nyquist diagrams of experimental system under DC interference of 16 V

The evolution of EIS with time under 16 V DC interference is shown in Fig. 7. The impedance radius has a decreasing trend compared with previous experiments. The radius of the low-frequency arc is the largest at 7 h, and then, it decreases first and then increases. The equivalent circuit  $R(CR)$  is fitted for the Nyquist diagrams at 7 h as shown in Fig. 8 and that is fitted with  $R(C(R(RC)))$  at 20 h as shown

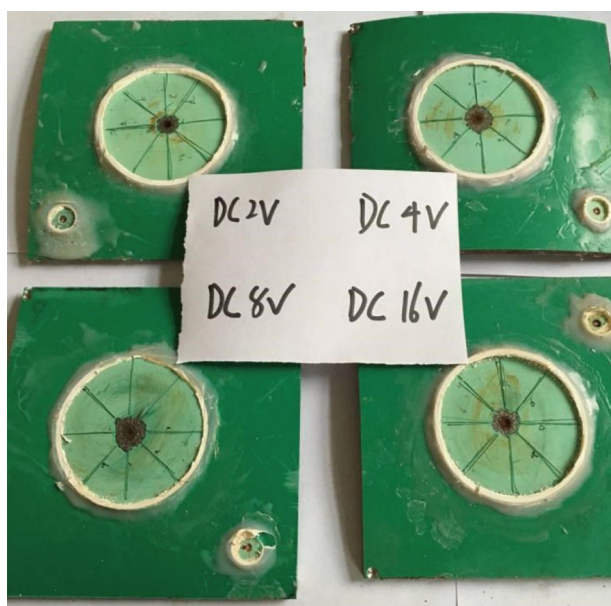
**Fig. 10** Cathodic disbonding diagram with positive DC interference

After finishing the electrochemical tests, the defect hole of the specimen is processed, and the disbonding distance of each test group is obtained as given in Table 5. At the end of the experiment, the cathode disbonding of the sample is shown in Fig. 10.

As given in Table 5 and shown in Fig. 10, the disbonding distance of specimens increases from 2 to 8 V DC interference, and the disbonding distance decreases under 16 V DC interference. This is consistent with the results shown in EIS.

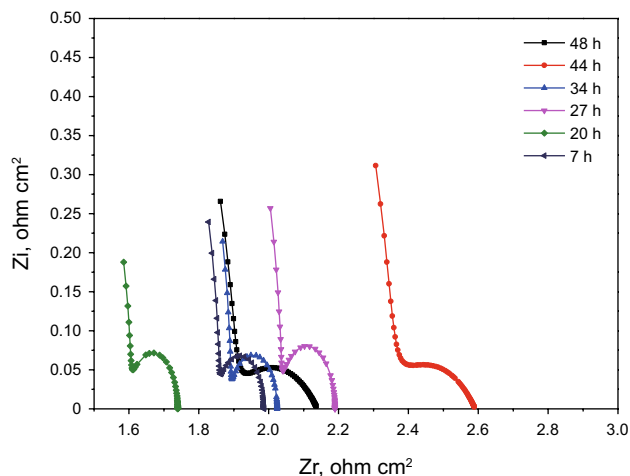
**Fig. 11** Nyquist diagrams of experimental system under DC interference voltage of  $-2 \text{ V}$

The evolution of the impedance of the system with  $-2$  V DC interference is shown in Fig. 11. The arcs of the high-frequency section move left and right on the coordinate axis, indicating that the impedance of the high-frequency band changes greatly with time. It can be seen from the figure that whether positive DC stray current or negative DC stray current is applied, the right end of the high-frequency arc could not completely form a semicircular arc, and the low-frequency arc starts to be derived, and this is because of the large defects in the experimental system. The corrosive medium will diffuse laterally along the interface between coating and metal substrate, which also penetrates the coating longitudinally to the interface. Both types of infiltration will work together to cause this phenomenon. The circuits within first 34 h are fitted with the circuit diagram shown in Fig. 3, and the circuit shown in Fig. 4 is selected at 44 h or 48 h. The fitting results are given in Table 6.

As given in Table 6, the value of  $R_c$  fluctuates, and it represents the fluctuation of the impedance value of the coating and corrosion products, which is consistent with the law shown in Fig. 11. The resistance decreases from 7 to 20 h, which is due to the gradual failure of the coating. From 20 to 48 h,  $R_c$  fluctuates up and down, and this is the display of the coating disbonding. With the process of disbonding, the gap between the coating and the metal is increasing gradually, and there will be some areas in the gap that the medium cannot reach. Crevice corrosion is very likely to occur in these places and produce corrosion products. The fluctuation of  $R_c$  value is the result of the reaction of the cathode reaction and crevice corrosion. Before 44 h, the  $R_t$  value has been between  $0.1 \Omega \text{ cm}^2$  and  $0.16 \Omega \text{ cm}^2$ , indicating that between 7 and 44 h, the difficulty of charge transfer is unchanged

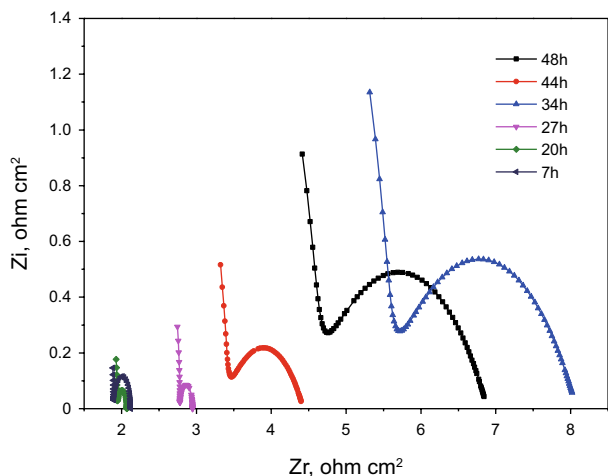
**Fig. 12** Nyquist diagrams of experimental system under DC interference voltage of  $-4\text{ V}$

The impedance evolution under  $-4 \text{ V}$  DC interference is shown in Fig. 12. Compared with that of  $-2 \text{ V}$  DC interference, the impedance range and impedance fluctuation increase significantly when  $-4 \text{ V}$  DC interference is applied. This is maybe that the DC interference voltage of  $-4 \text{ V}$  has a more significant effect on the disbonding of the coating at the defect hole of the coating, and it results in a greater degree of cathodic reaction and anode corrosion. The fitting results are given in Table 7.

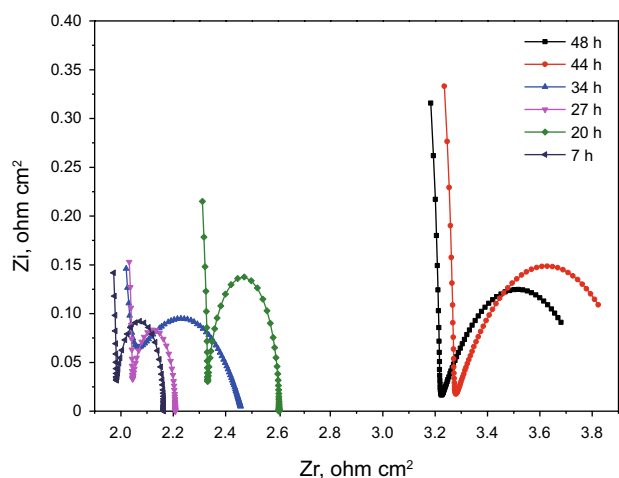
**Fig. 13** Nyquist diagrams of experimental system under DC interference of  $-8\text{ V}$

The impedance evolution diagram of the experimental system under  $-8\text{ V}$  DC interference is shown in Fig. 13. It can be seen that the impedance range and impedance fluctuation degree have been reduced with the increase in the DC interference voltage. The fitting results are given in Table 8. At the initial stage of the experiment, the charge transfer resistance  $R_l$  is small, indicating that the charge transfer process at the interface between the coating and the metal is relatively easy. At this stage, the coating has been preliminarily stripped. After 27 h, the value of  $R_c$  increases obviously and the  $R_l$  value increases several times, indicating that the disbonding state of the coating entered a new stage, and the crevice corrosion intensifies, which results in the increase in corrosion products and the widening of the disbonding range. In comparison with the value of  $R_l$  in Table 7, the  $R_l$  decreases under  $-8\text{ V}$  DC interference. It shows that the speed of the cathode disbonding in the  $-8\text{ V}$  DC interference test is faster than that of  $-4\text{ V}$ , and the disbonding degree is greater.

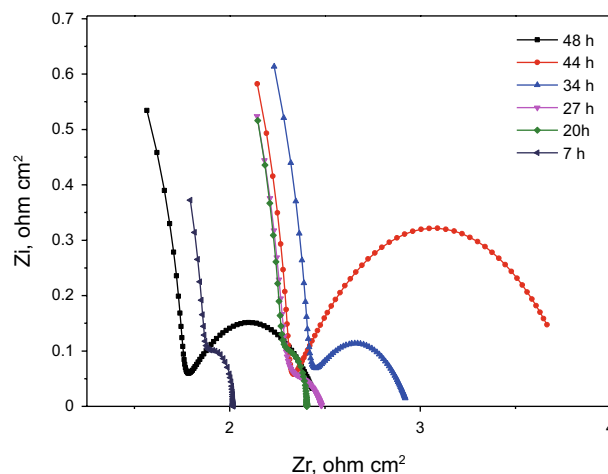
**Fig. 14** Nyquist diagrams of experimental system under DC interference voltage of  $-16\text{ V}$

The impedance evolution of the system under the DC interference of  $-16\text{ V}$  is shown in Fig. 14. It can be seen that as the interference voltage continues to increase, the impedance range decreases. Therefore, from the total impedance range, it can be inferred that the degree of disbonding of the coating is greater than before. The fitting results are given in Table 9. In this experiment, W appears at 27 h, and it indicates that the cathodic exfoliation speed of the coating is faster than that under the influence of  $-16\text{ V}$  DC interference.

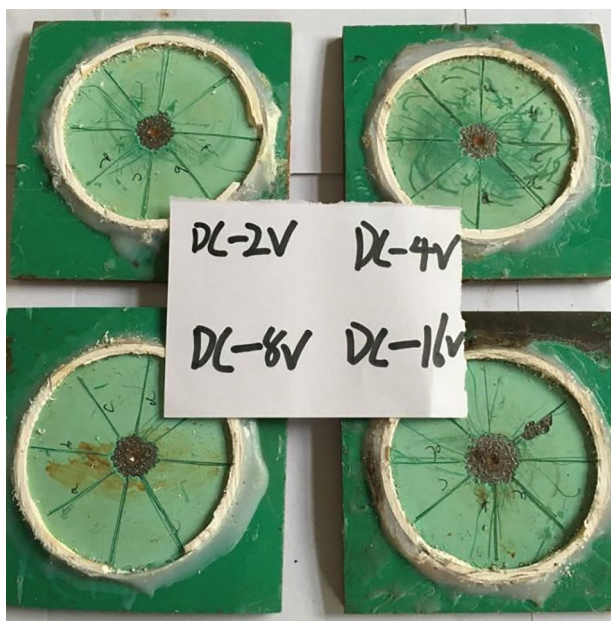
**Fig. 15** Cathodic disbonding diagram with negative DC interference

After finishing the experiments of the negative DC interference, the physical photographs of the samples are taken as shown in Fig. 15, and the disbonding distance of the anticorrosive layer is given in Table 10.

As shown in Fig. 15 and Table 10, when the epoxy powder coating was under the interference of negative DC stray current, the disbonding distance increases with the increase in voltage magnitude, and the results are consistent with the results obtained by the impedance spectroscopy.

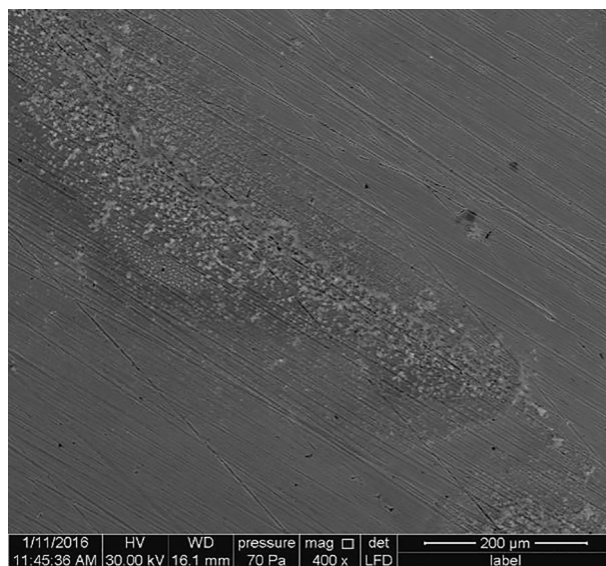
**Fig. 16** Micromorphology of metal surface without interference test

At the end of the test period, after the electrode faces of the test group are cleaned up, corrosion morphology pictures are taken by the scanning electron microscope, as shown in Figs. 16, 17 and 18.

As shown in Fig. 16, few of small pits are observed on the surface of the electrodes without DC stray interference, and no obvious corrosion pits are observed. When DC interference voltage of  $8\text{ V}$  is applied on the samples, a large number of corrosion pits appear on the surface of the metal, and a corrosion ditch has been formed. As shown in Fig. 18,

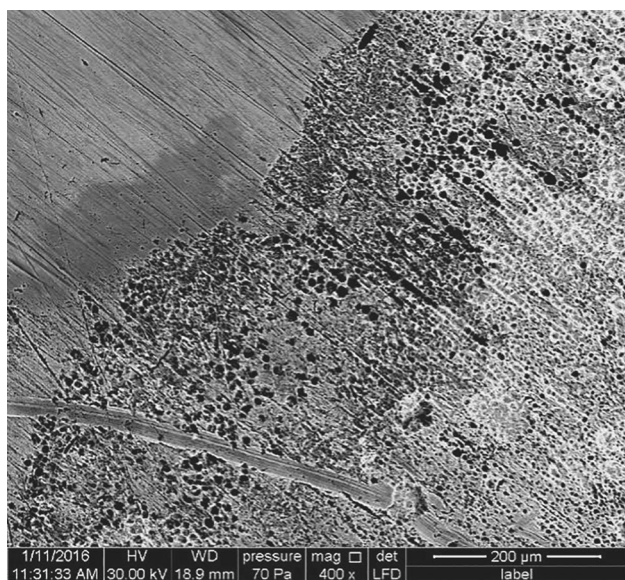
**Fig. 18** Micromorphology of metal surface with DC interference voltage of  $-8\text{ V}$

the corrosion zone and the noncorrosion zone have a clear boundary line, and the boundary line is the edge region where the coating is peeled off. A large number of corrosion pits appear in the disbonding area, which is the characteristic of crevice corrosion and DC stray current corrosion. The microscopic appearance confirms the existence of anodic corrosion as the main reaction process in cathode disbonding. It also shows that under the disturbance of stray current, the degree of anode corrosion increases significantly, and the disbonding speed of the coating accelerates. That is, DC stray current promotes the cathodic disbonding of coatings.
